NASA CR-54323  
EOS REPORT 4920-Final

# ION ROCKET SYSTEM RESEARCH AND DEVELOPMENT

NATIONAL AERONAUTICS AND SPACE ADMINISTRATION

**ELECTRO-OPTICAL SYSTEMS, INC.,** Pasadena, California  
A Subsidiary of Xerox Corporation

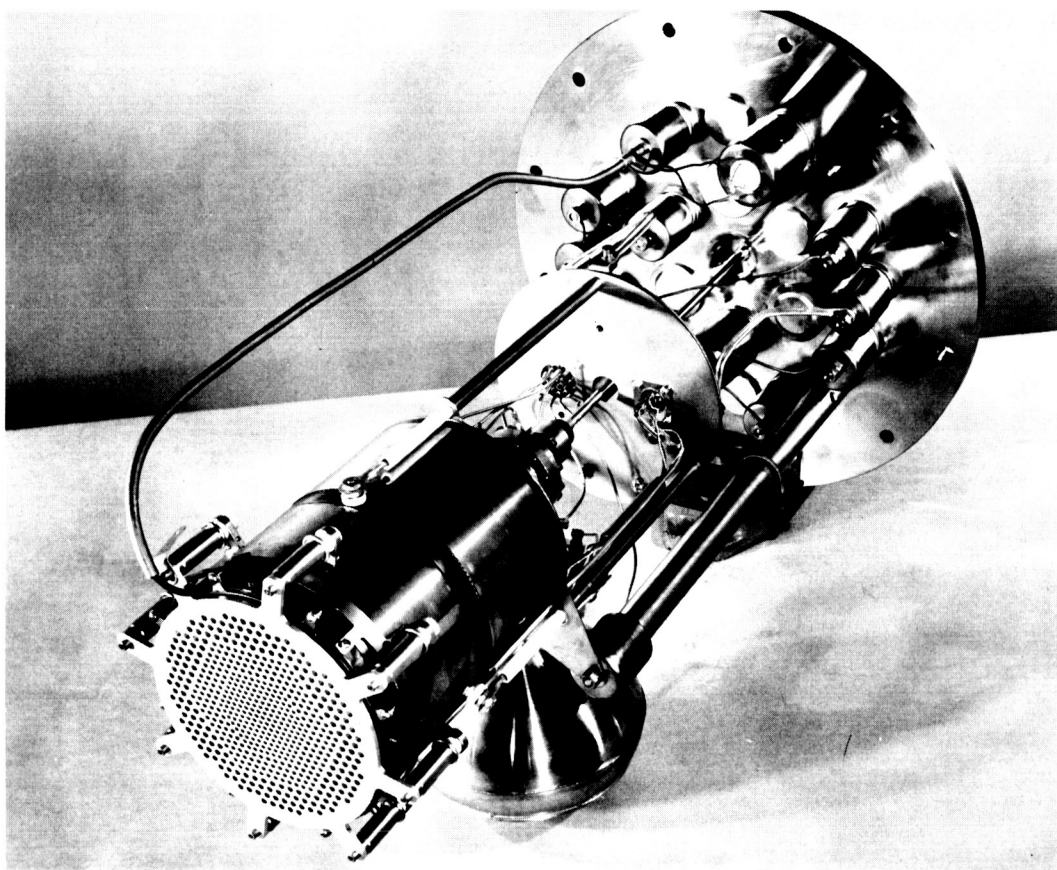
FIG. 55 DF ENGINE WITH 750-HOUR FEED SYSTEM

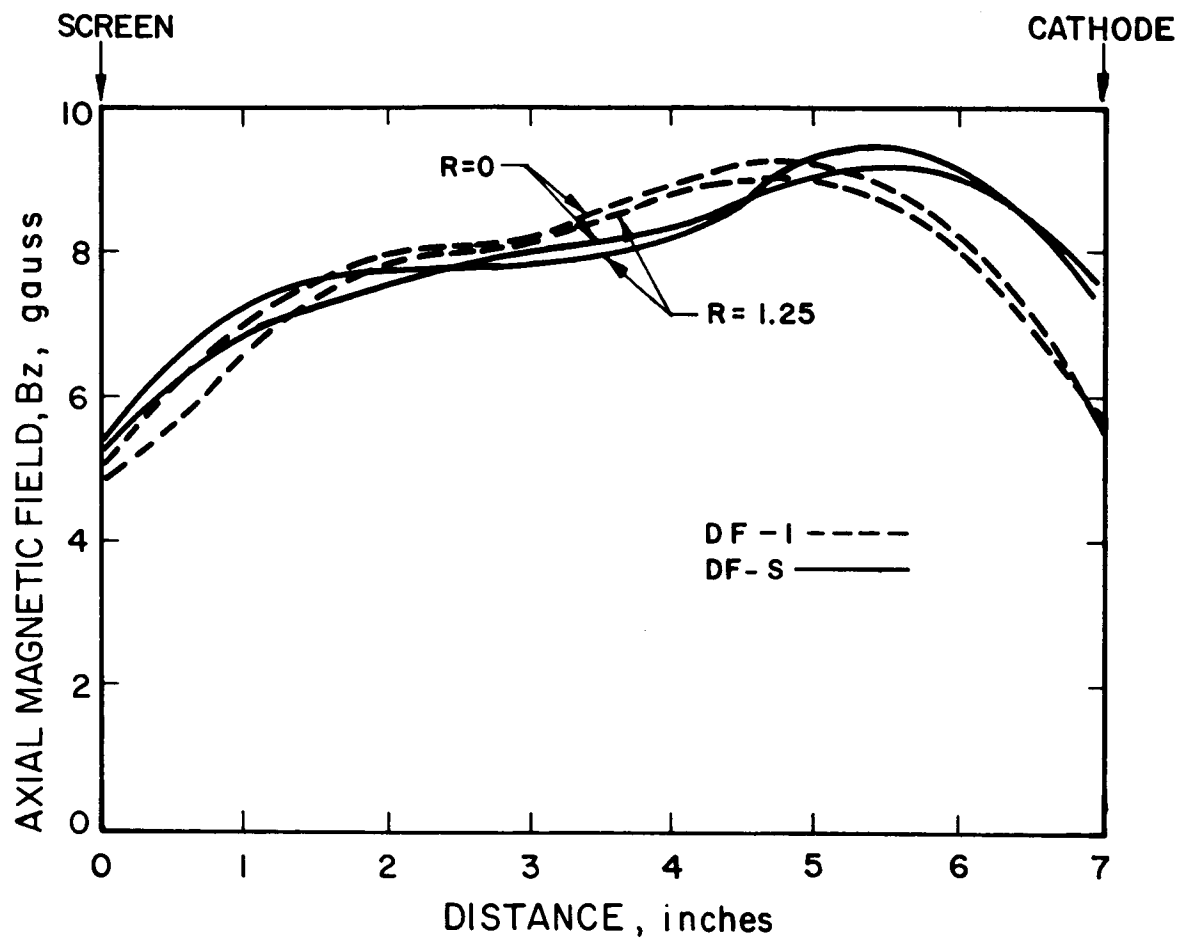
FIG. 59 DF-S AND DF-1 MAGNETIC FIELD PLOTS

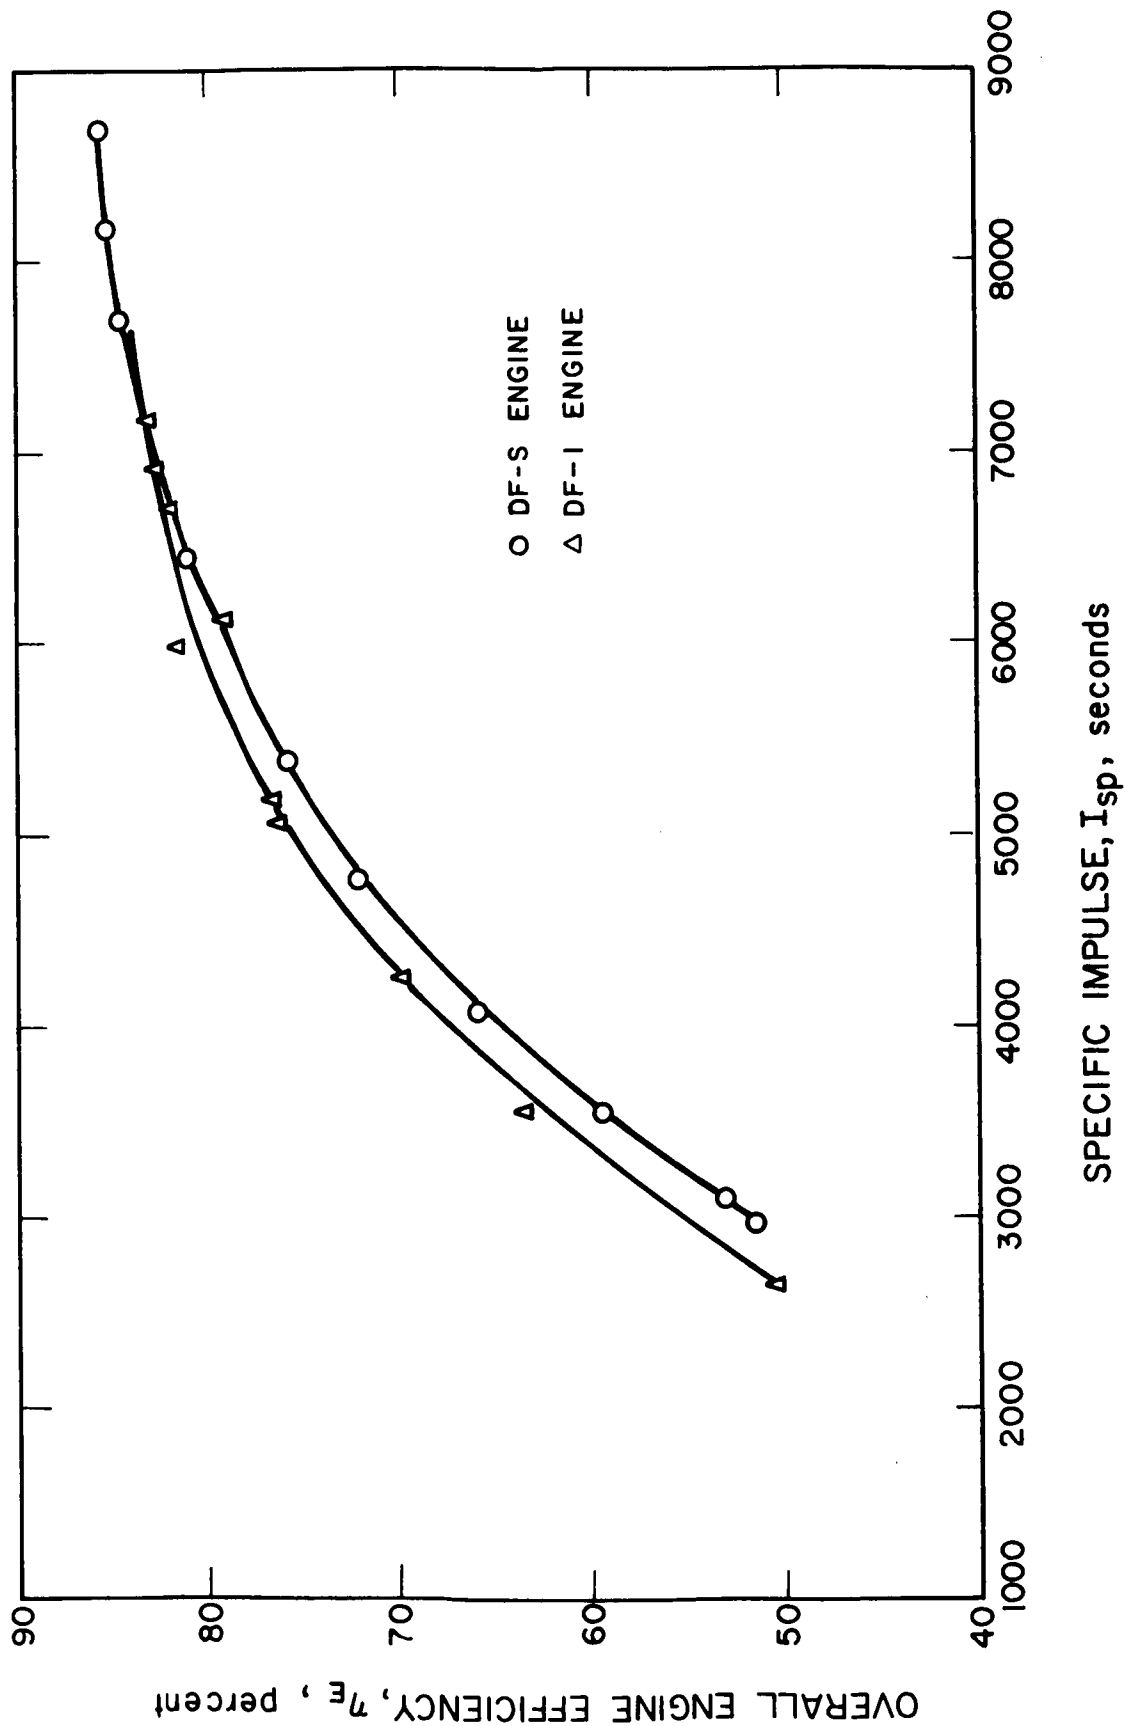
FIG. 60 DF-S AND DF-1 OVERALL ENGINE EFFICIENCIES

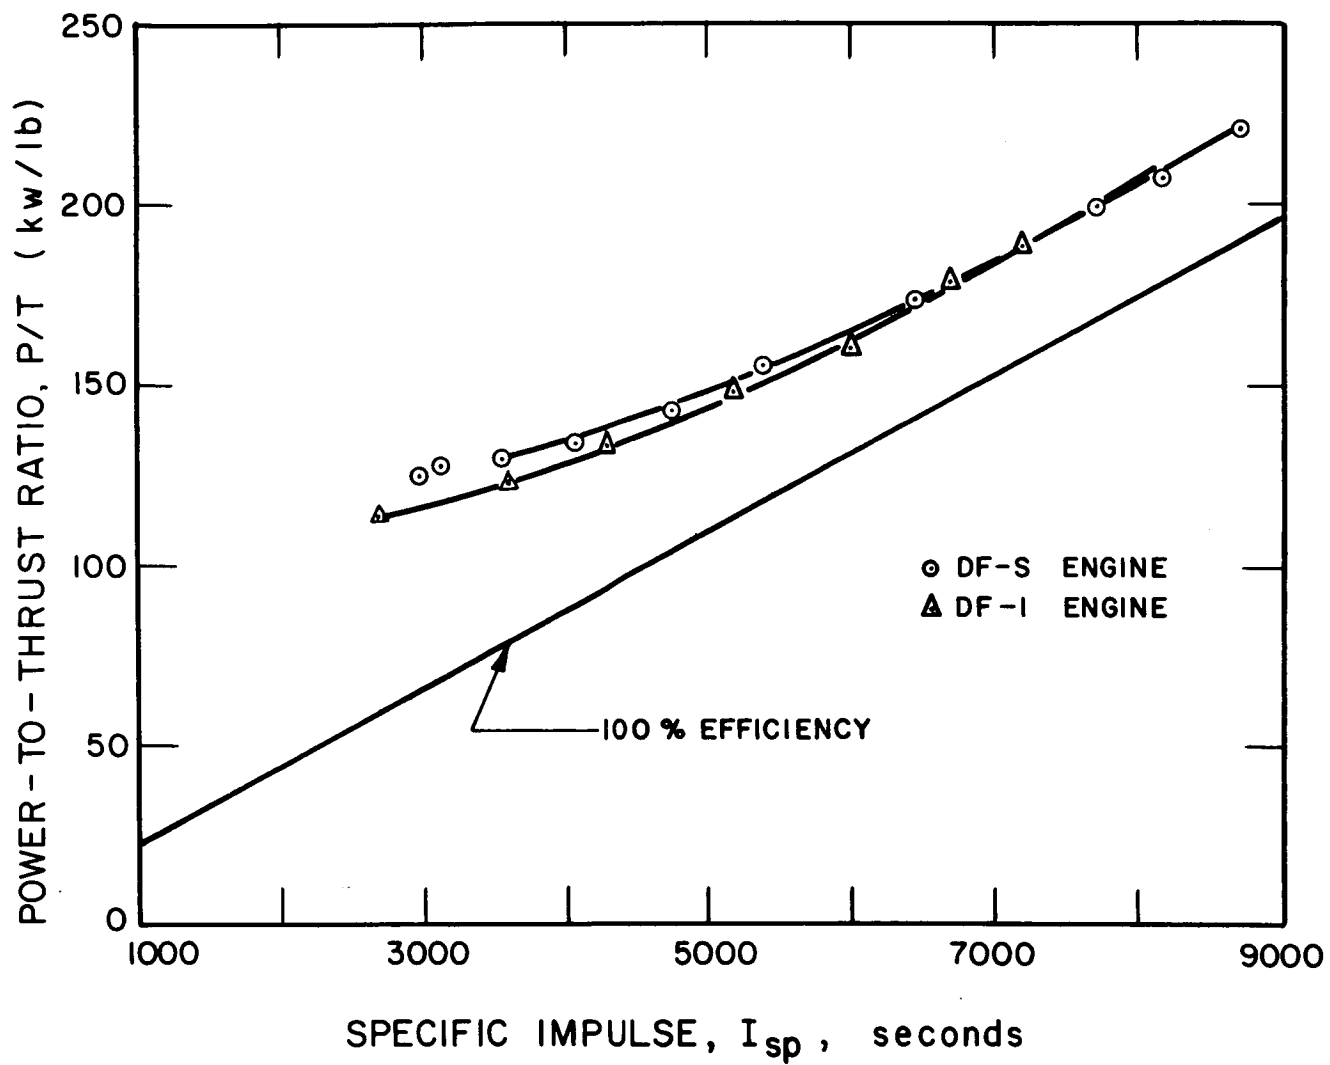
FIG. 61 DF-S AND DF-1 POWER-TO-THRUST RATIOS

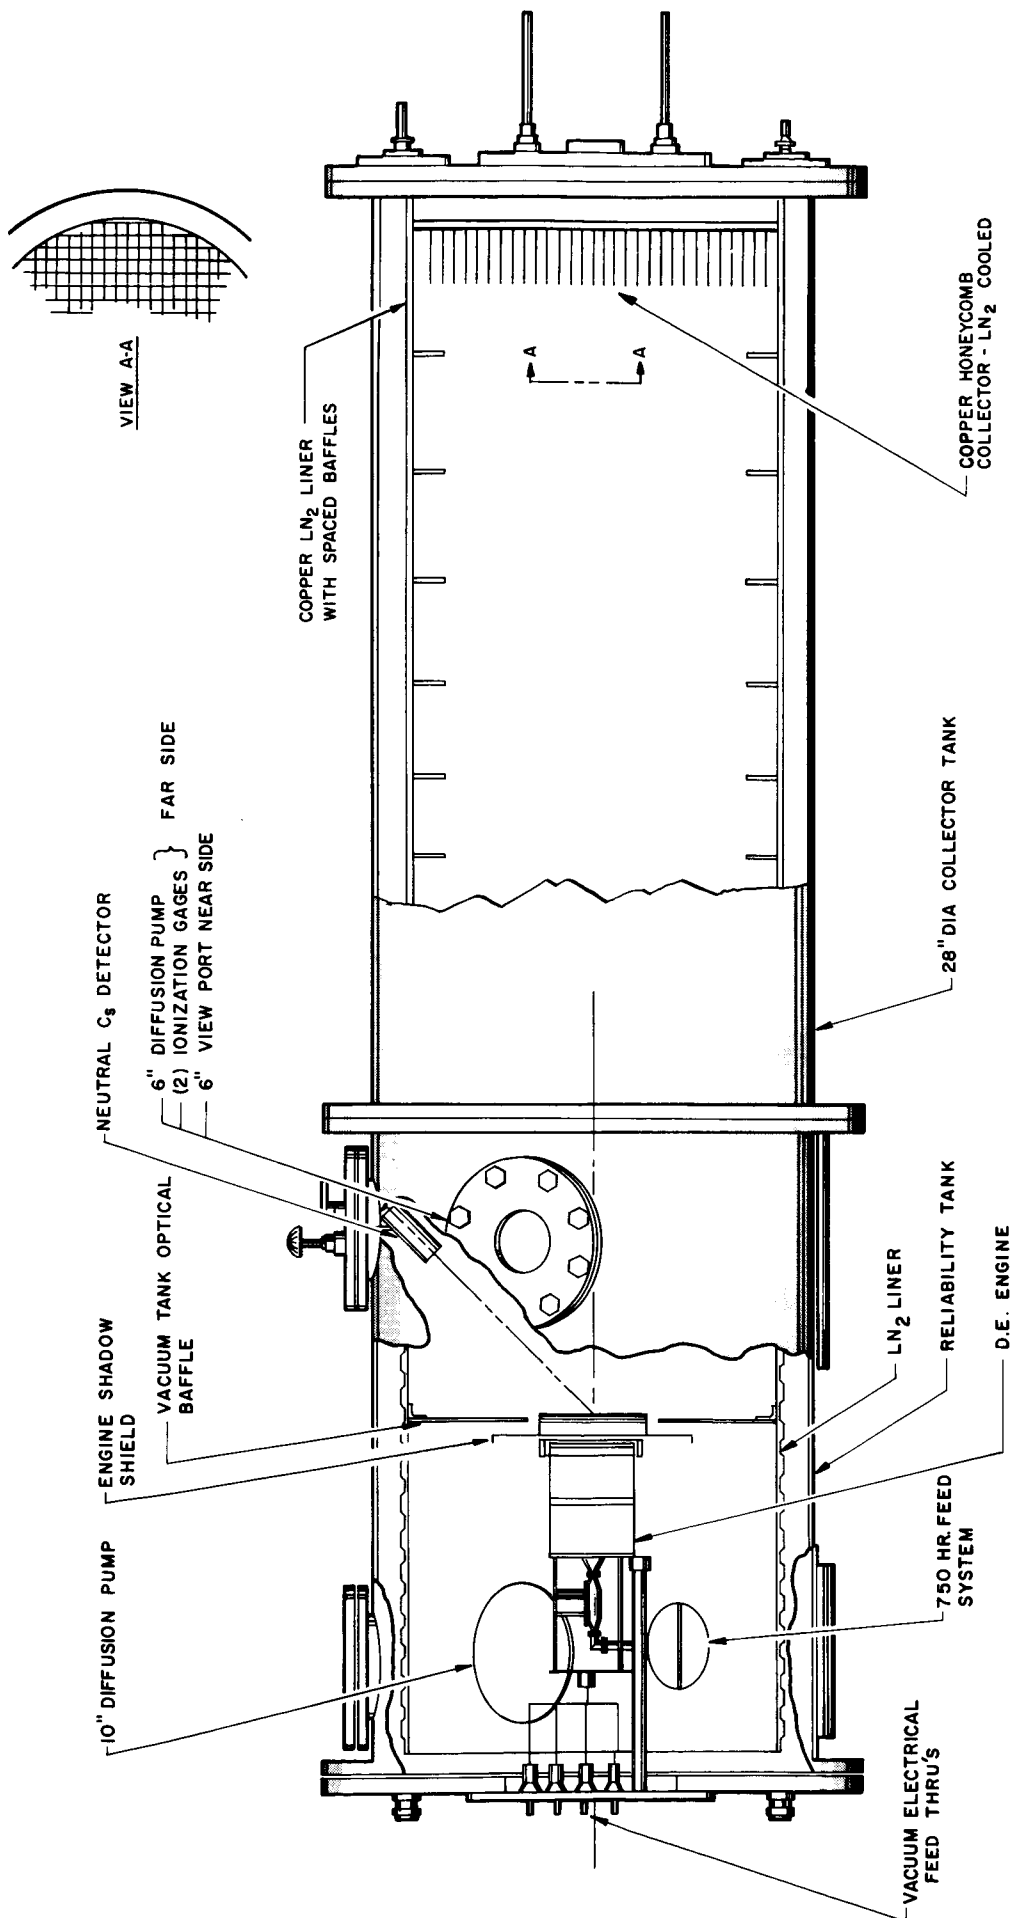
FIG. 62 ENGINE TEST CHAMBER

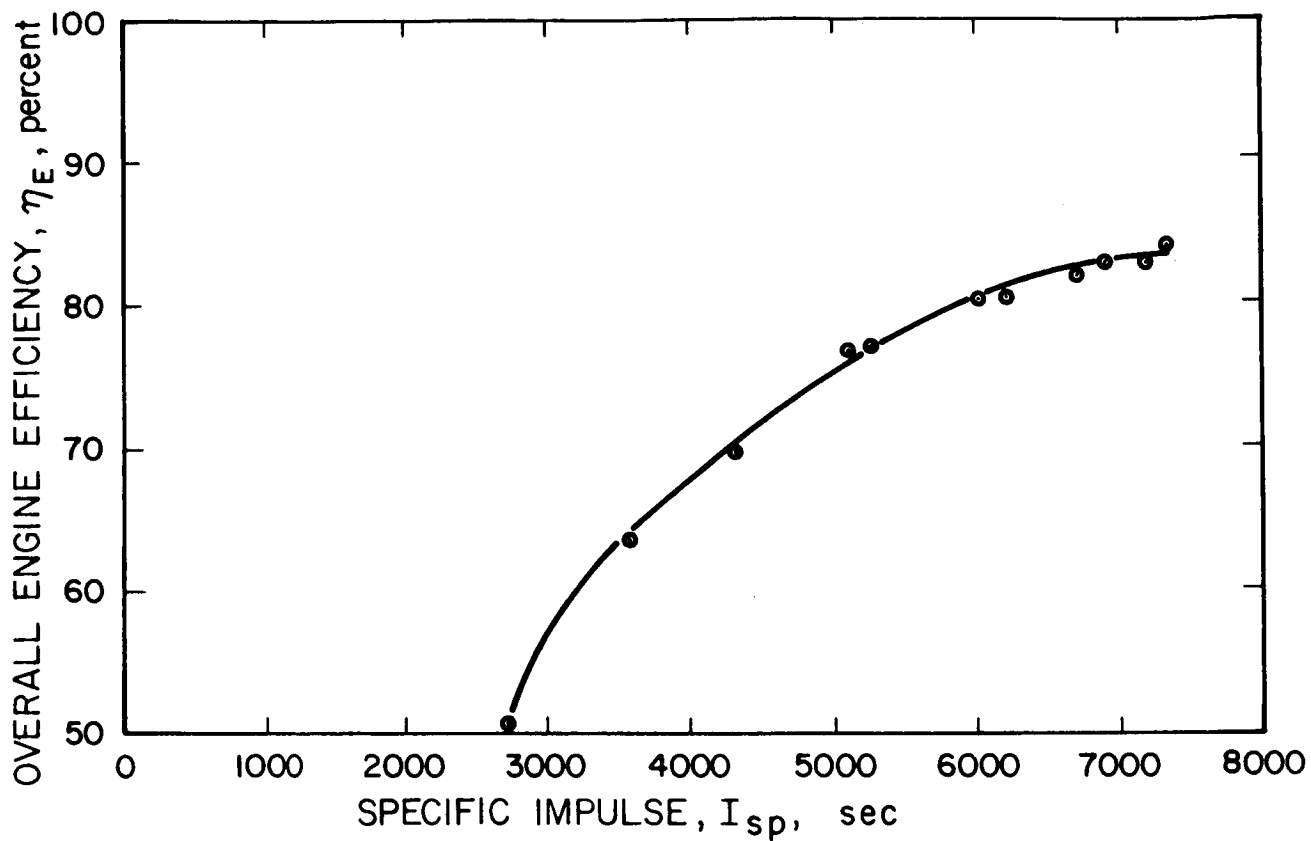
FIG. 63 DF-1 ENGINE OVERALL EFFICIENCY VERSUS SPECIFIC IMPULSE

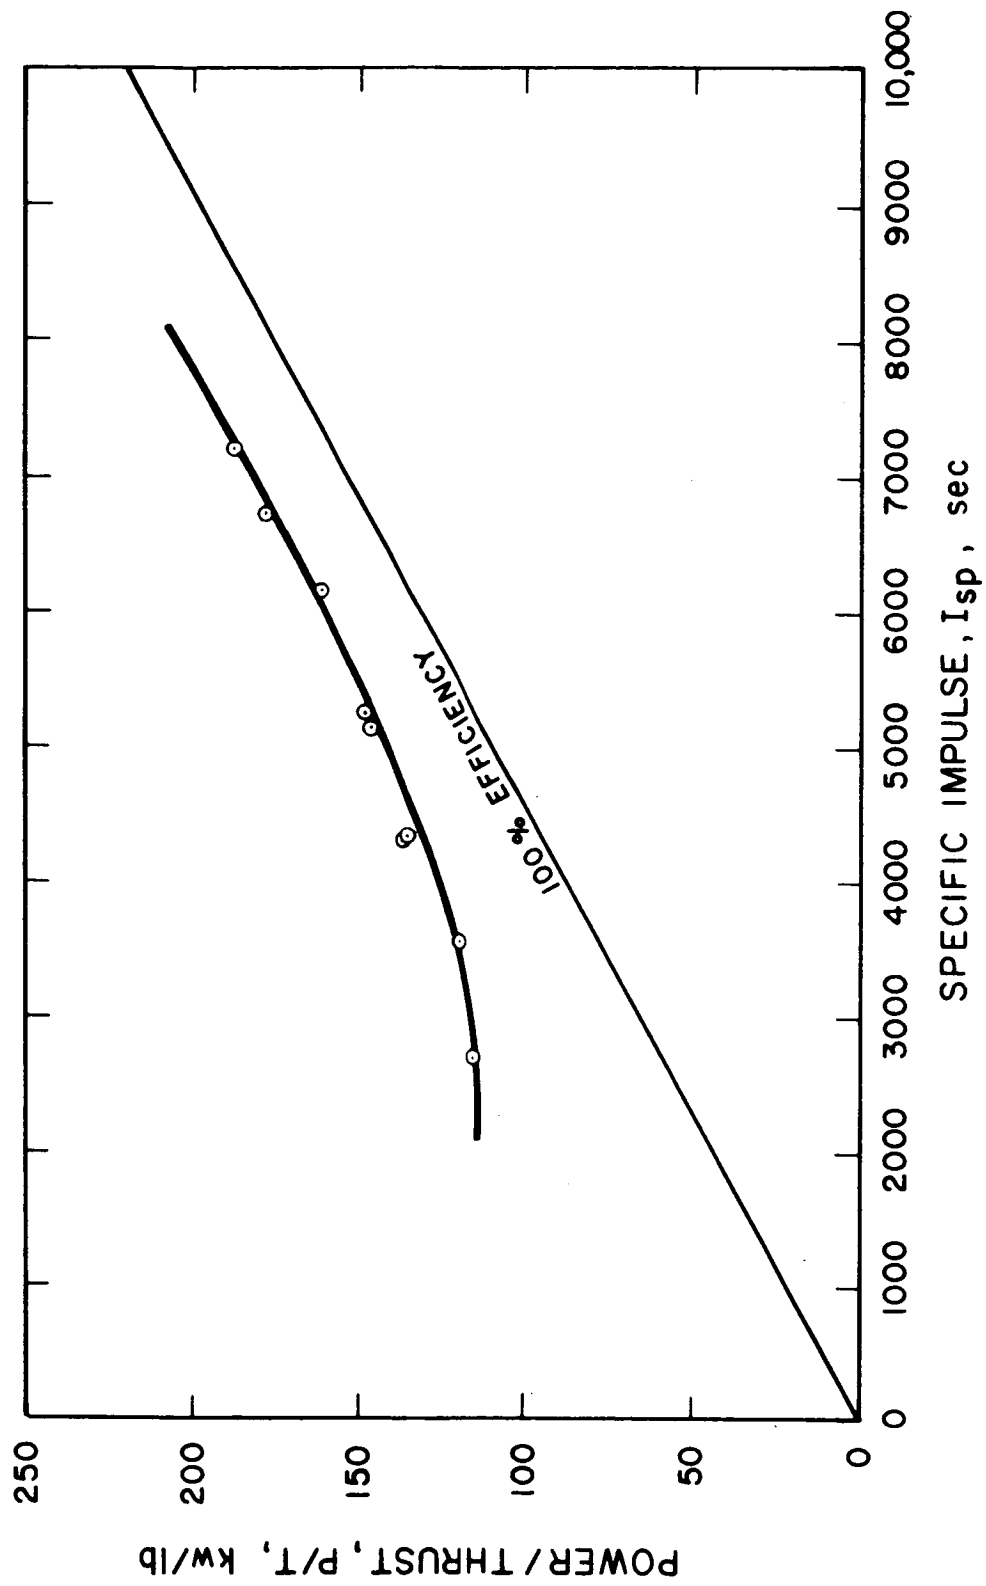
FIG. 64 POWER-TO-THRUST RATIO VERSUS SPECIFIC IMPULSE FOR DF ENGINE

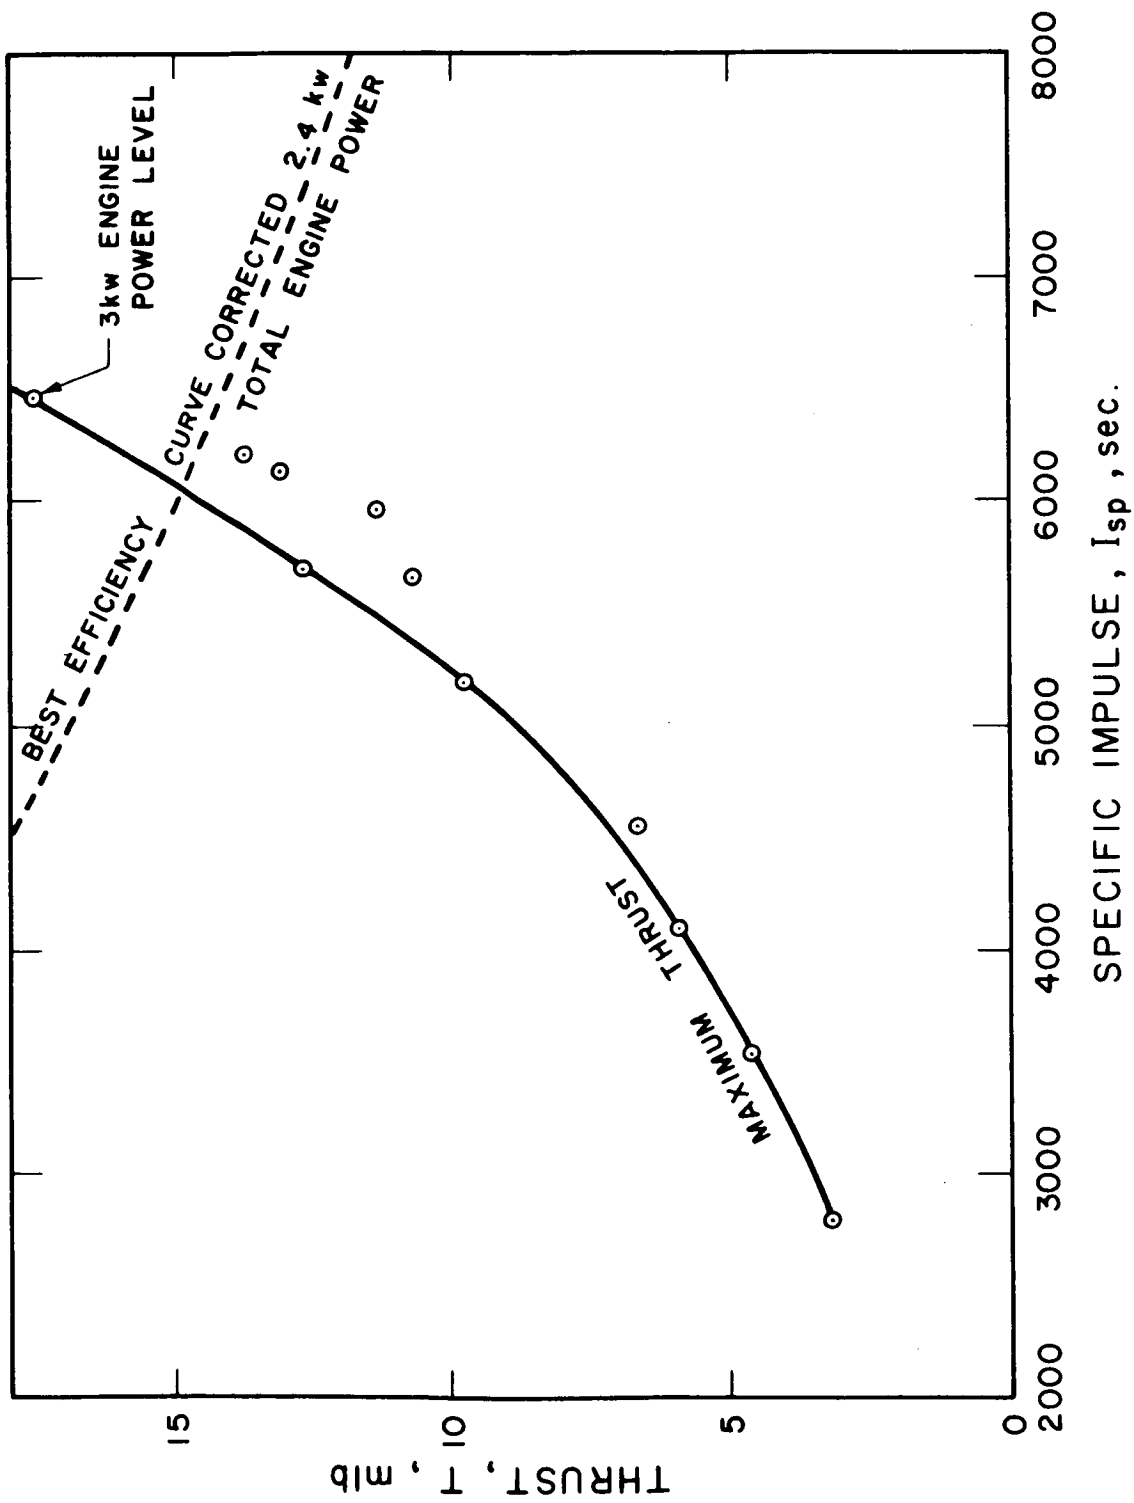
FIG. 65 DF ENGINE THRUST VERSUS SPECIFIC IMPULSE

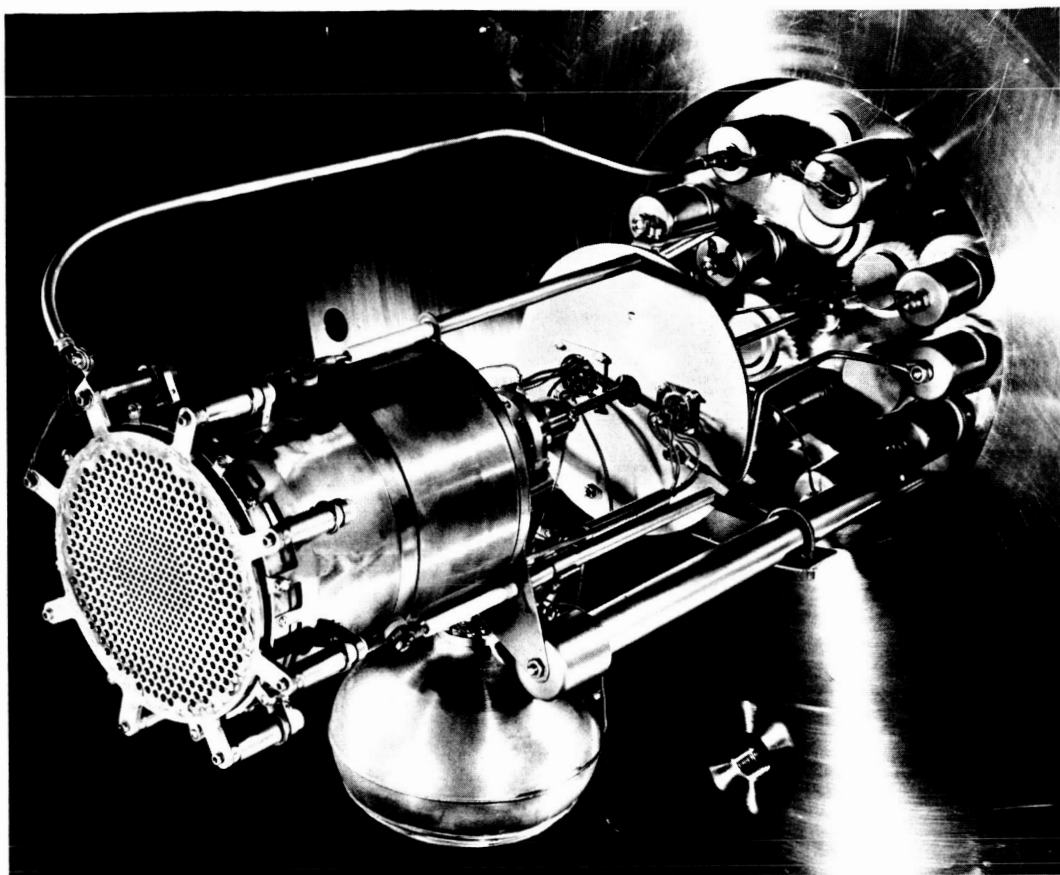
FIG. 69 DF-1 ENGINE SYSTEM AFTER 1,772 HOURS CUMULATIVE OPERATION

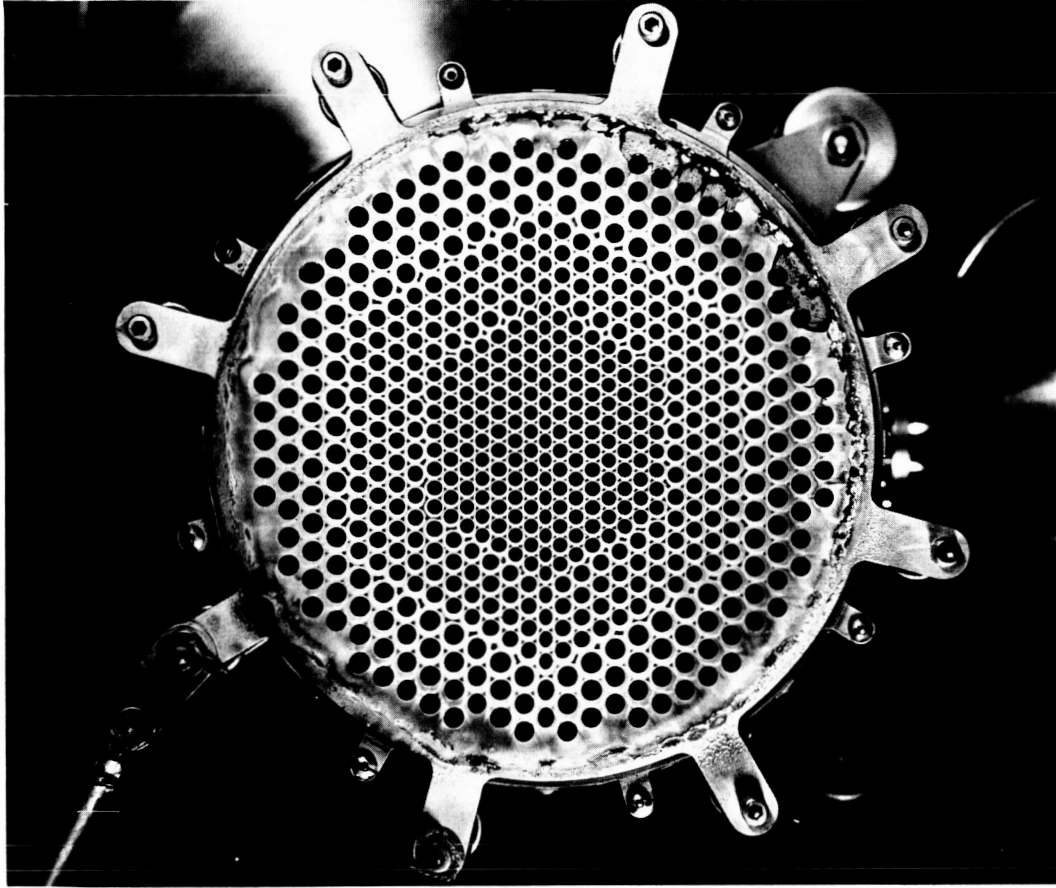
FIG. 71 DF-1 ENGINE SYSTEM AFTER 1,772 HOURS CUMULATIVE OPERATION

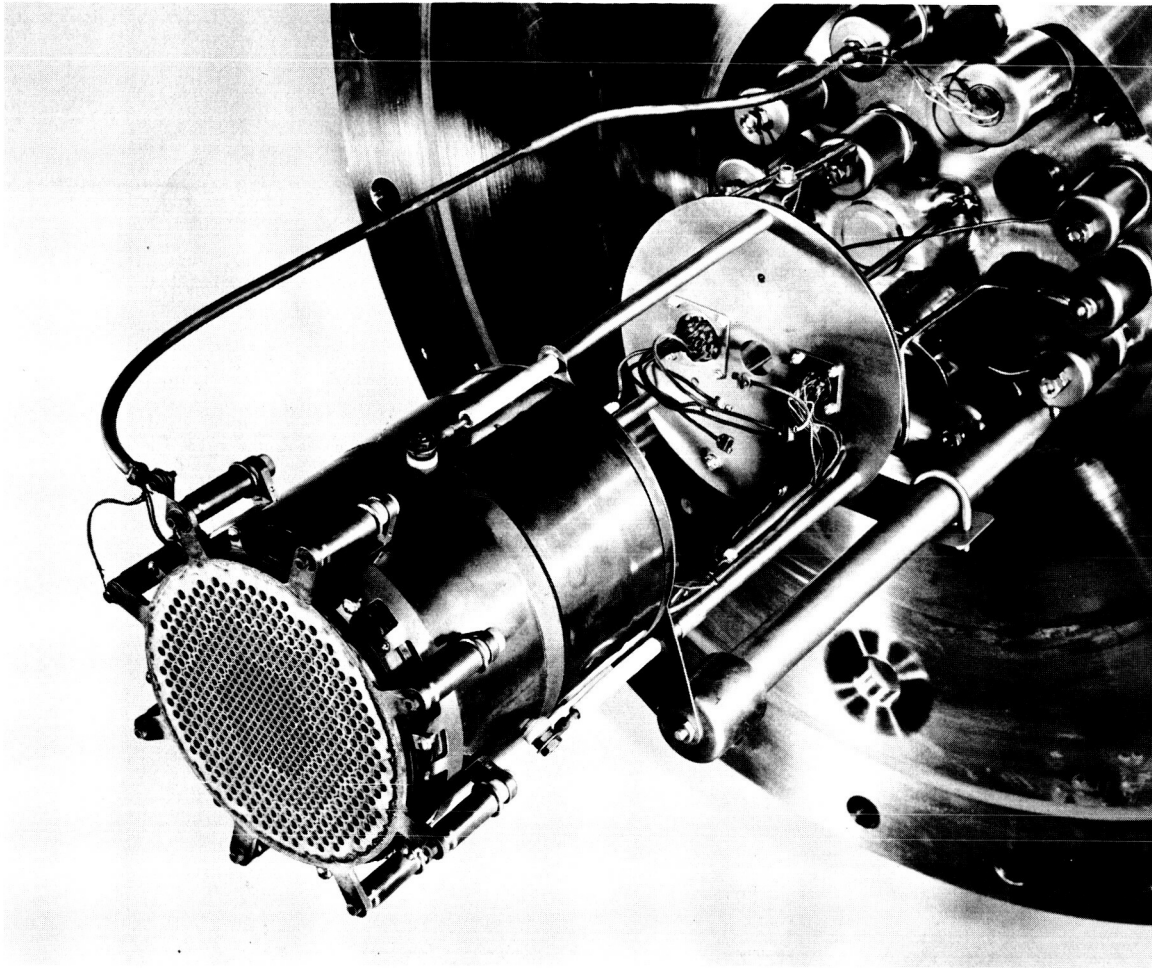
FIG. 72 DF-1 ENGINE AFTER 2610 HOURS CUMULATIVE OPERATION WITH FEED SYSTEM REMOVED

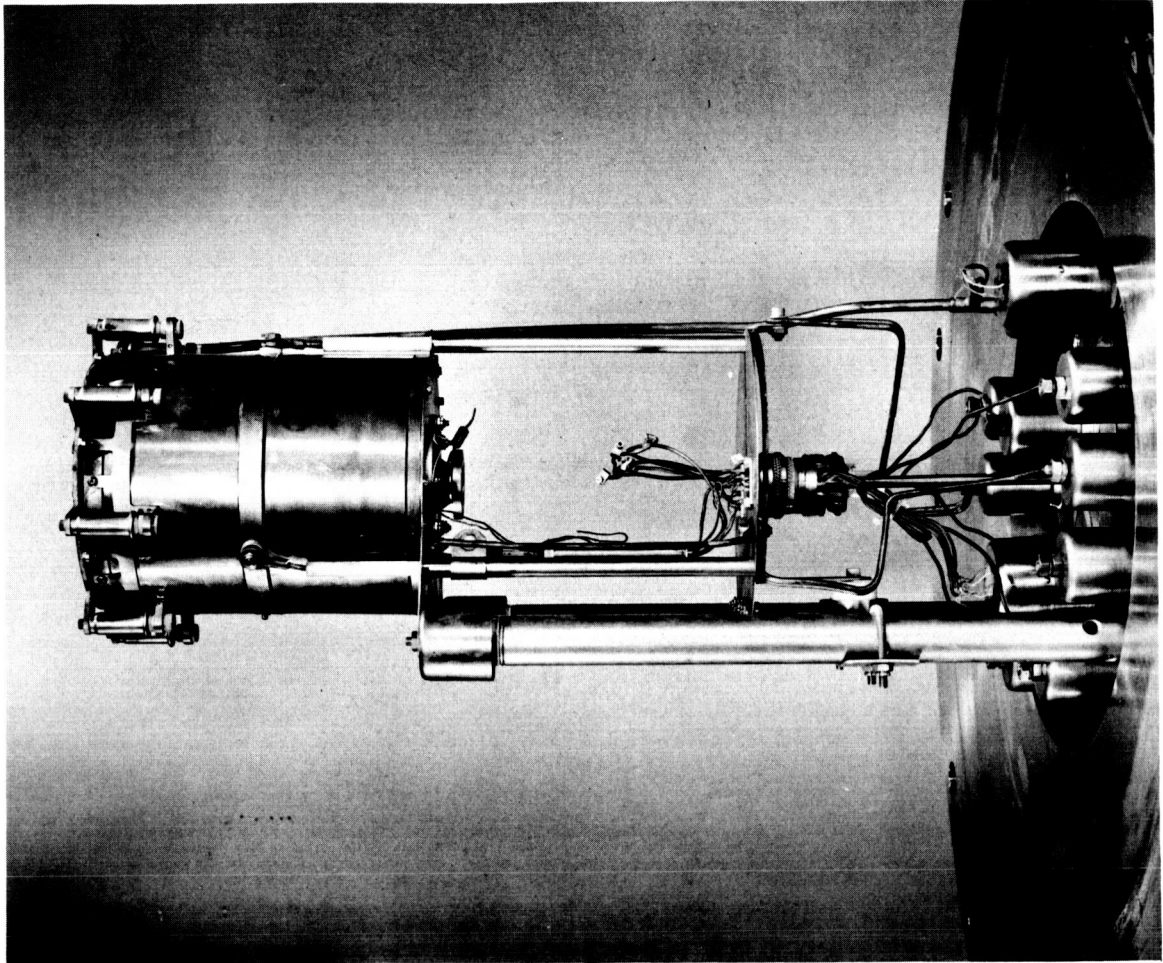
FIG. 73 DF-1 ENGINE AFTER 2610 HOURS CUMULATIVE OPERATION WITH FEED SYSTEM REMOVED

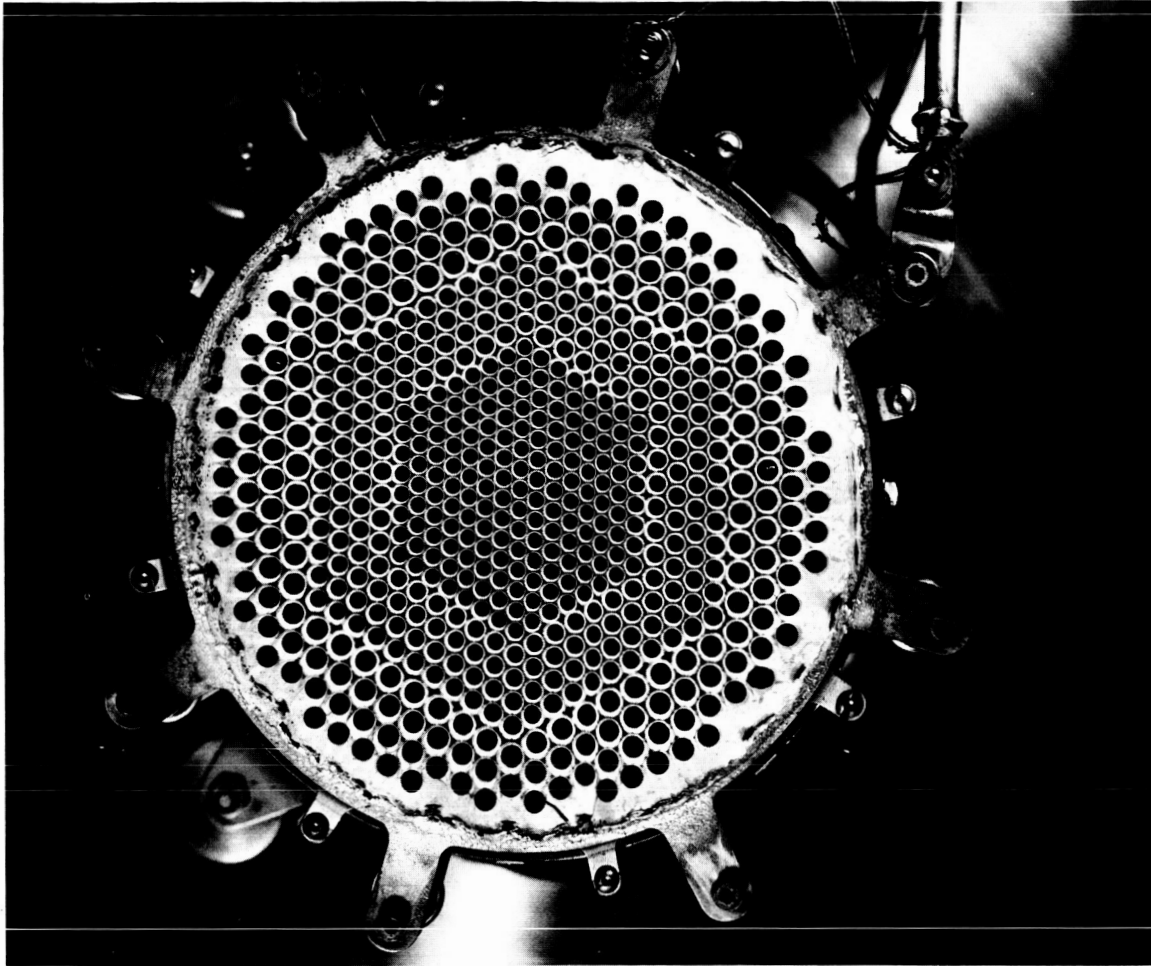
FIG. 74 DF-1 ENGINE AFTER 2610 HOURS CUMULATIVE OPERATION WITH FEED SYSTEM REMOVED

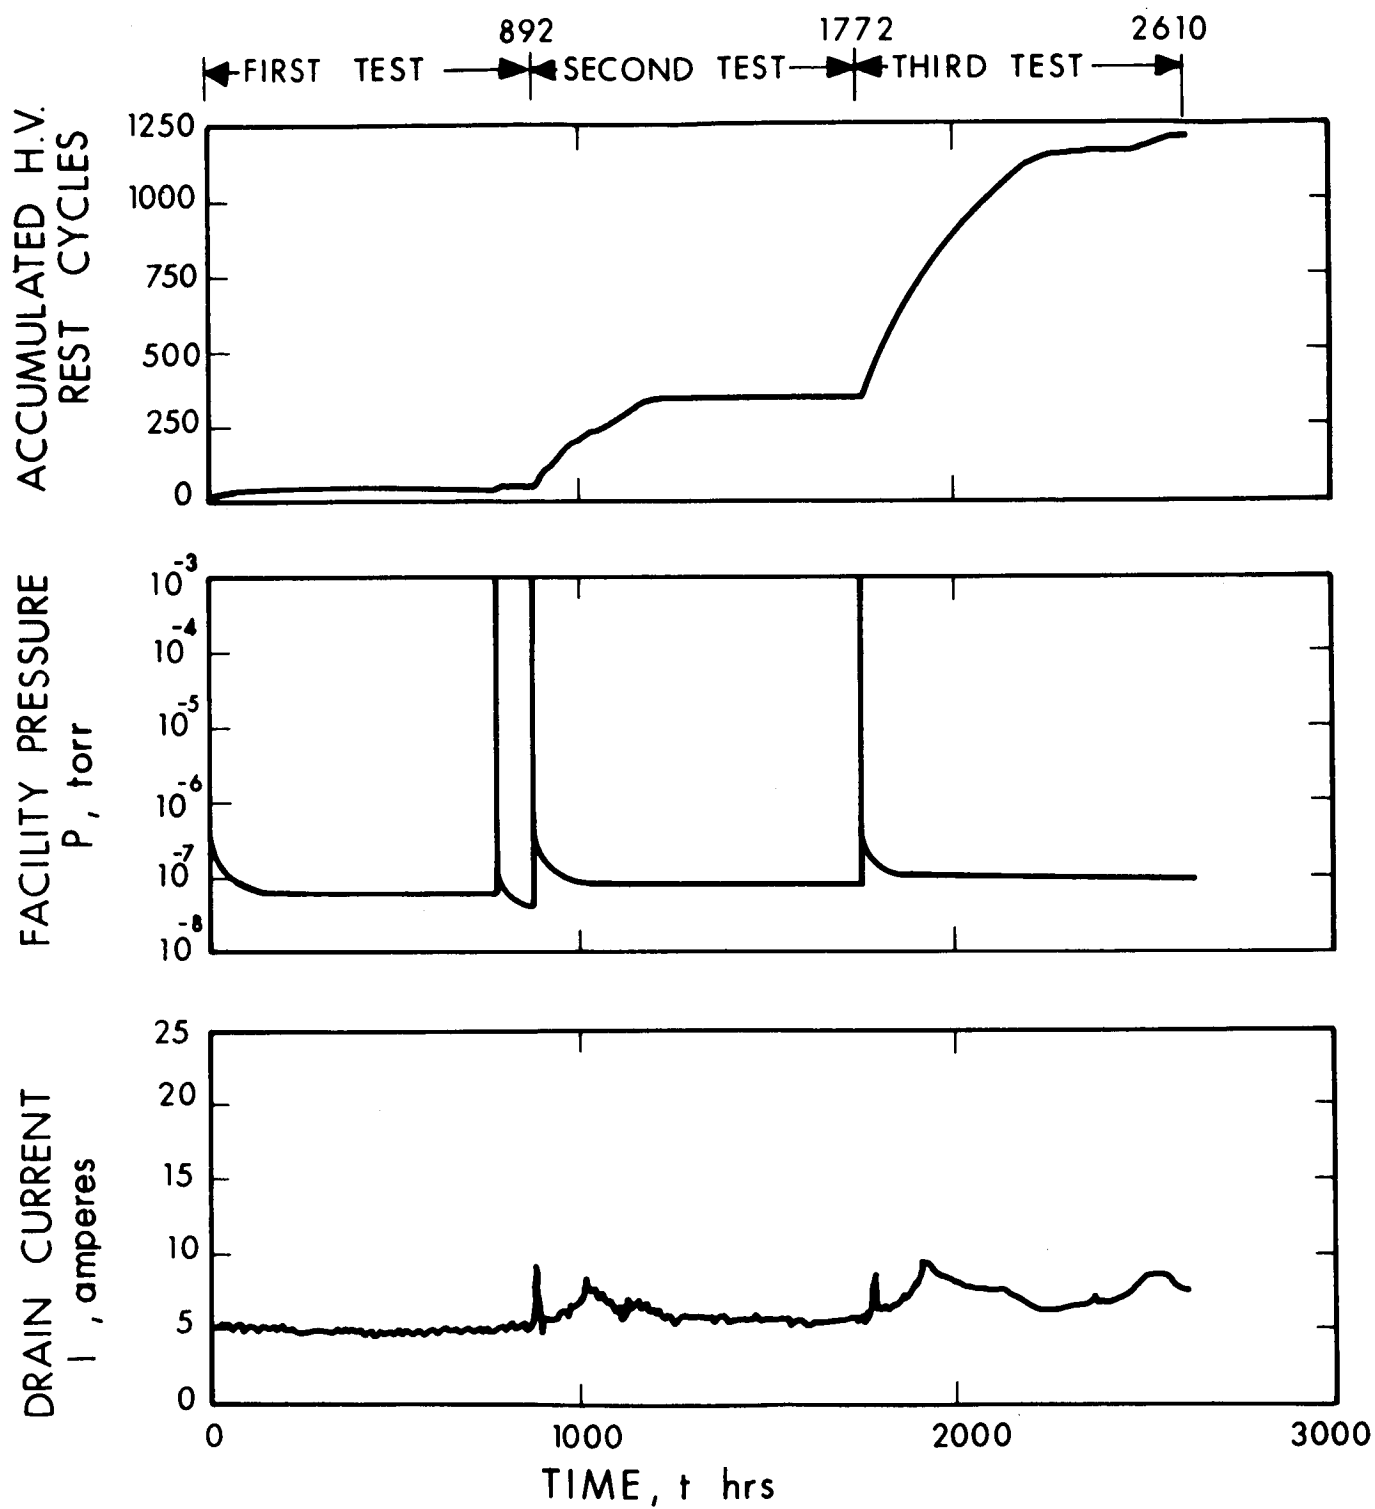
FIG. 75 TIME DEPENDENT FUNCTIONS FROM 2610-HOUR TEST

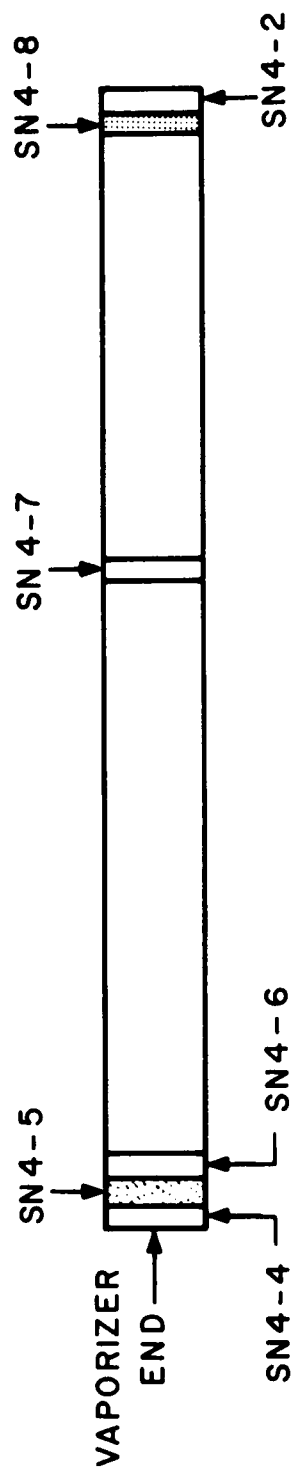
FIG. 76 POSITION OF SAMPLES TAKEN FROM POROUS ROD

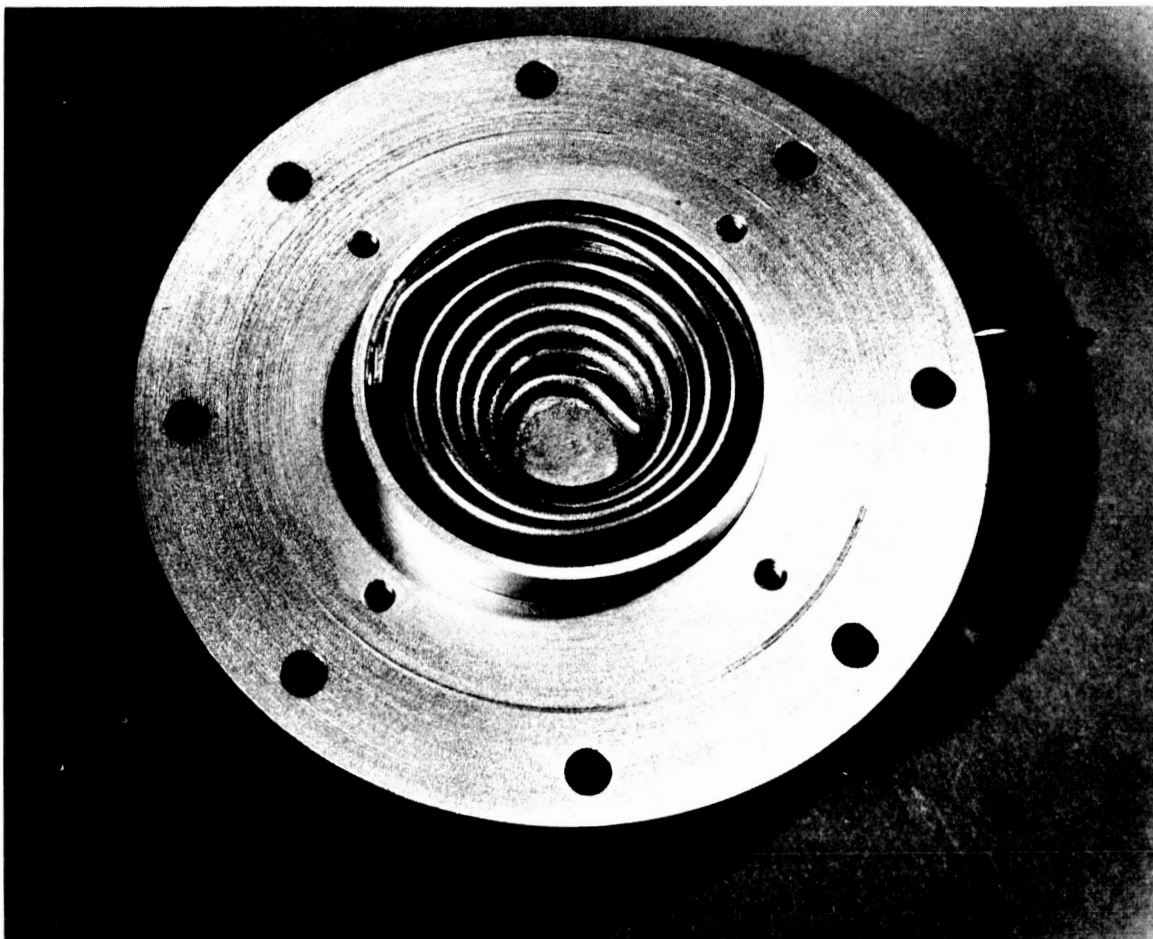
FIG. 77 DF-1 CATHODE AFTER 2610 HOURS CUMULATIVE OPERATION

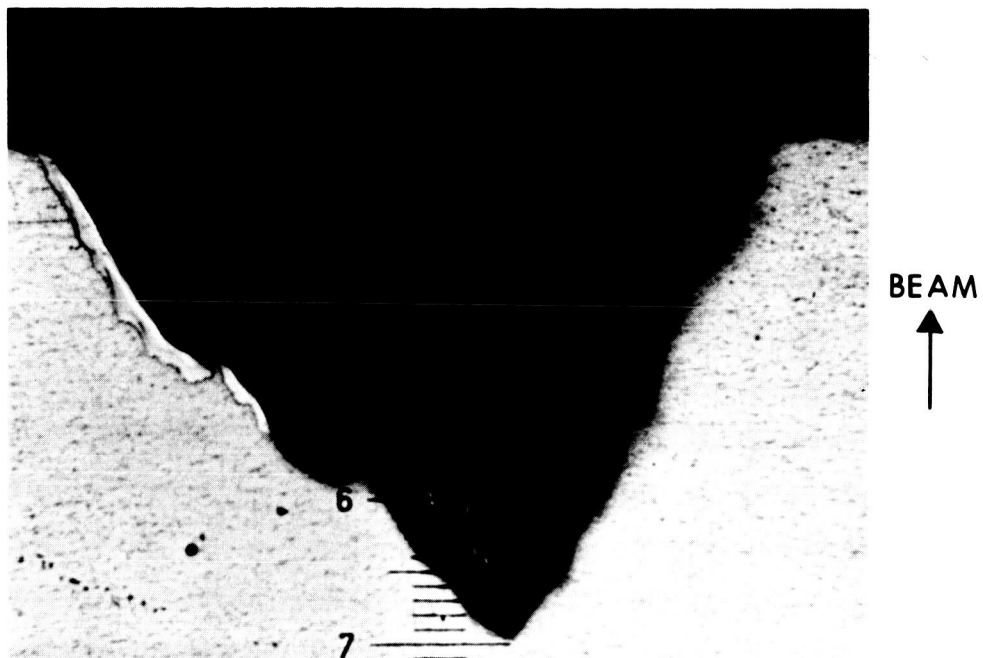
FIG. 79a CROSS SECTION OF THE DEEPEST PIT (X75)

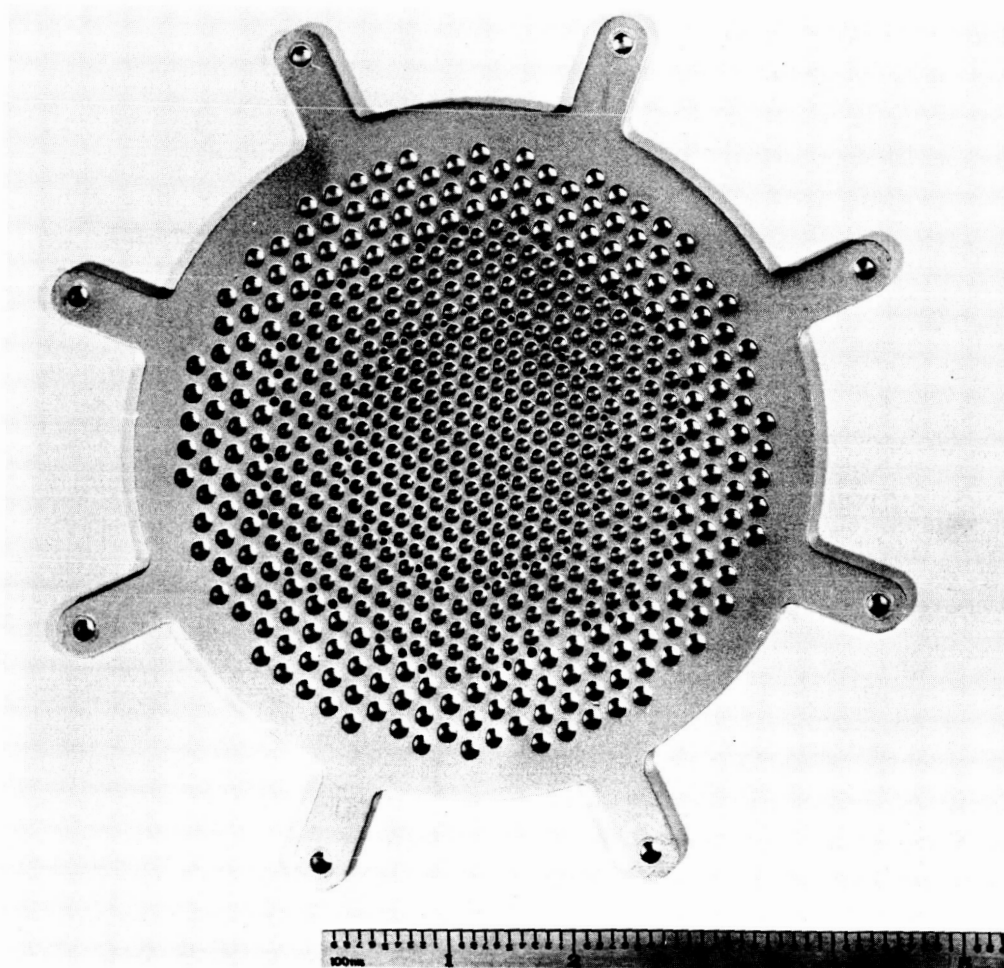
FIG. 84 DF ACCELERATOR ELECTRODE WITH HOLES DRILLED THROUGH  
AT EROSION PIT LOCATIONS

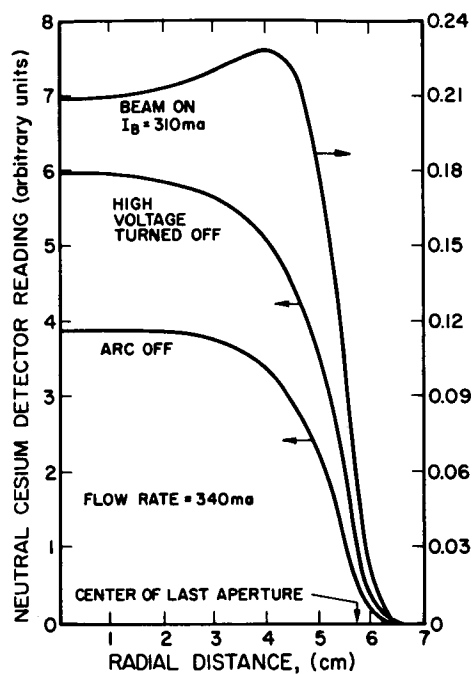
FIG. 86

VARIATION OF NEUTRAL EFFLUX DISTRIBUTION WITH BEAM ON, BEAM OFF, AND ARC OFF CONDITIONS
